St Magnus Graffiti Project, Stage 1

Survey Report

Survey Report (Final)

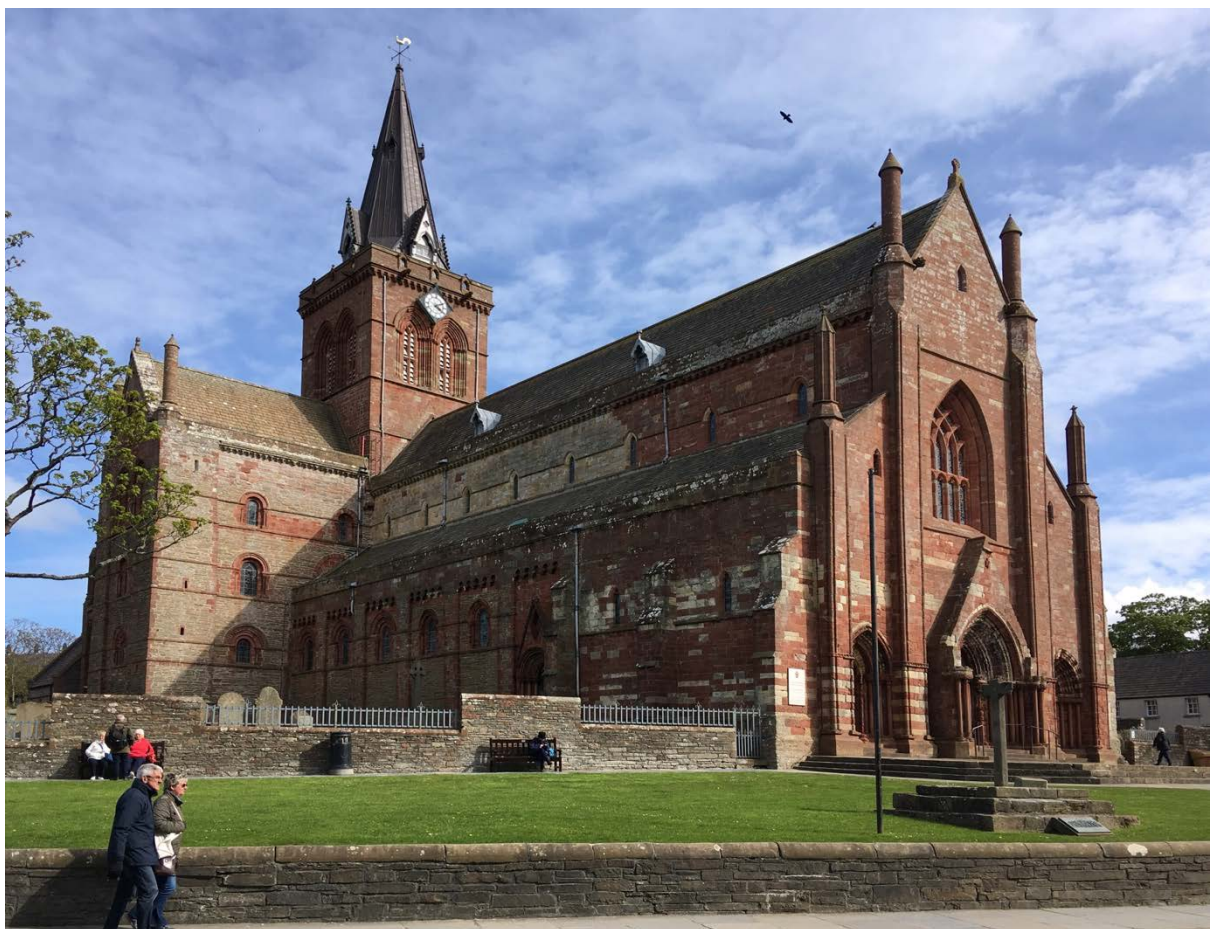
Figure 2: St Magnus Cathedral from Broad Street, looking SE. Note the different stonework at the western end of the northern elevation indicating the join between the Transitional and 15th-century phases. Photograph © Antonia Thomas.

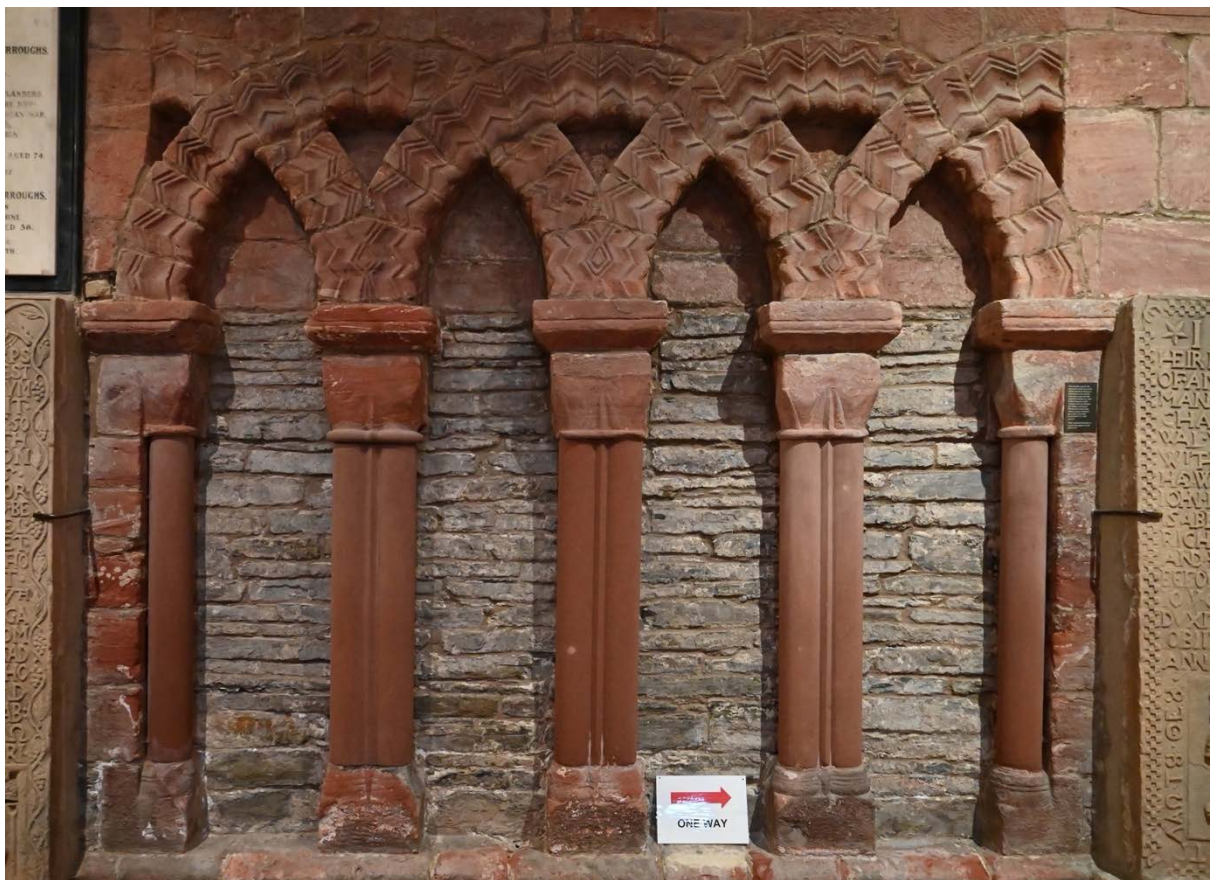
Figure 4: Romanesque decoration on the arches in the blind arcading in the nave. Photograph © Antonia Thomas.

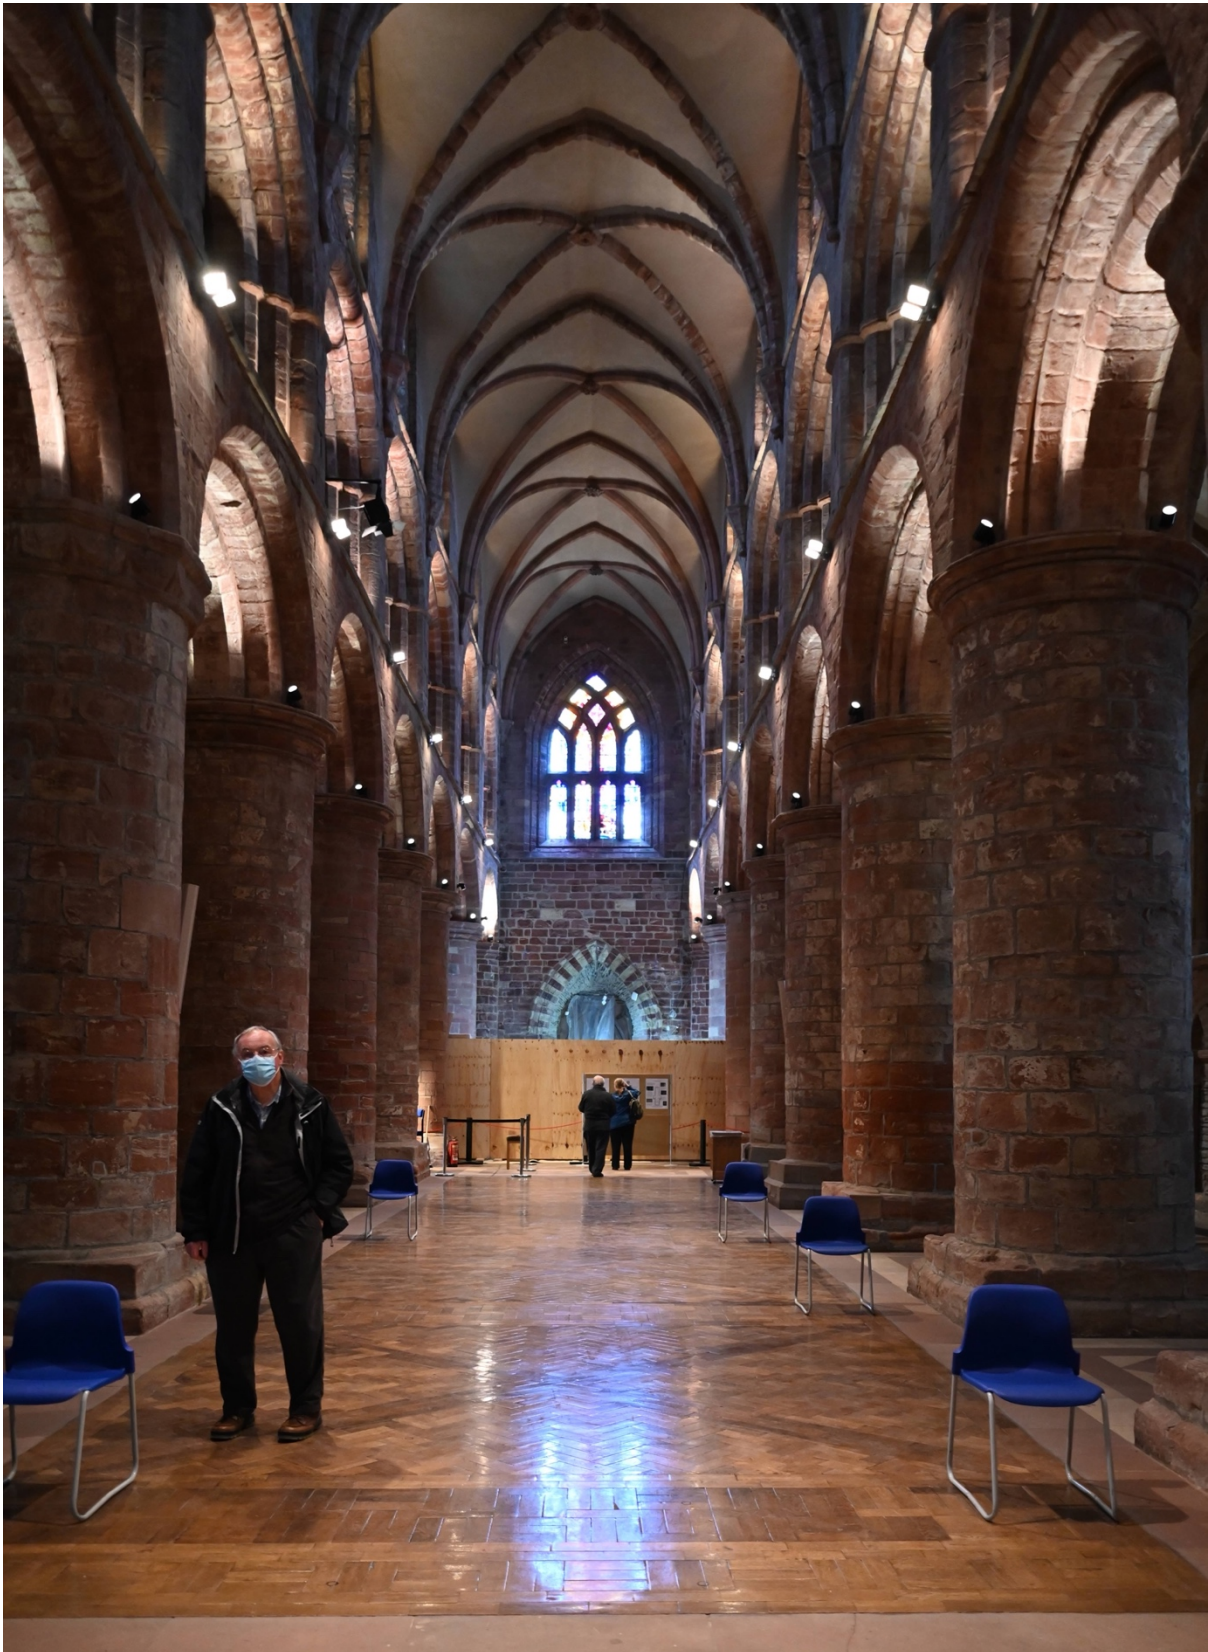
Figure 6: The relatively empty nave inside St Magnus Cathedral in June 2021, looking west. Note the hoarding at the west end which is partitioning off the area where building works are taking place, and the man wearing the facemask required for all visitors as a result of Covid regulations. Photograph © Antonia Thomas.

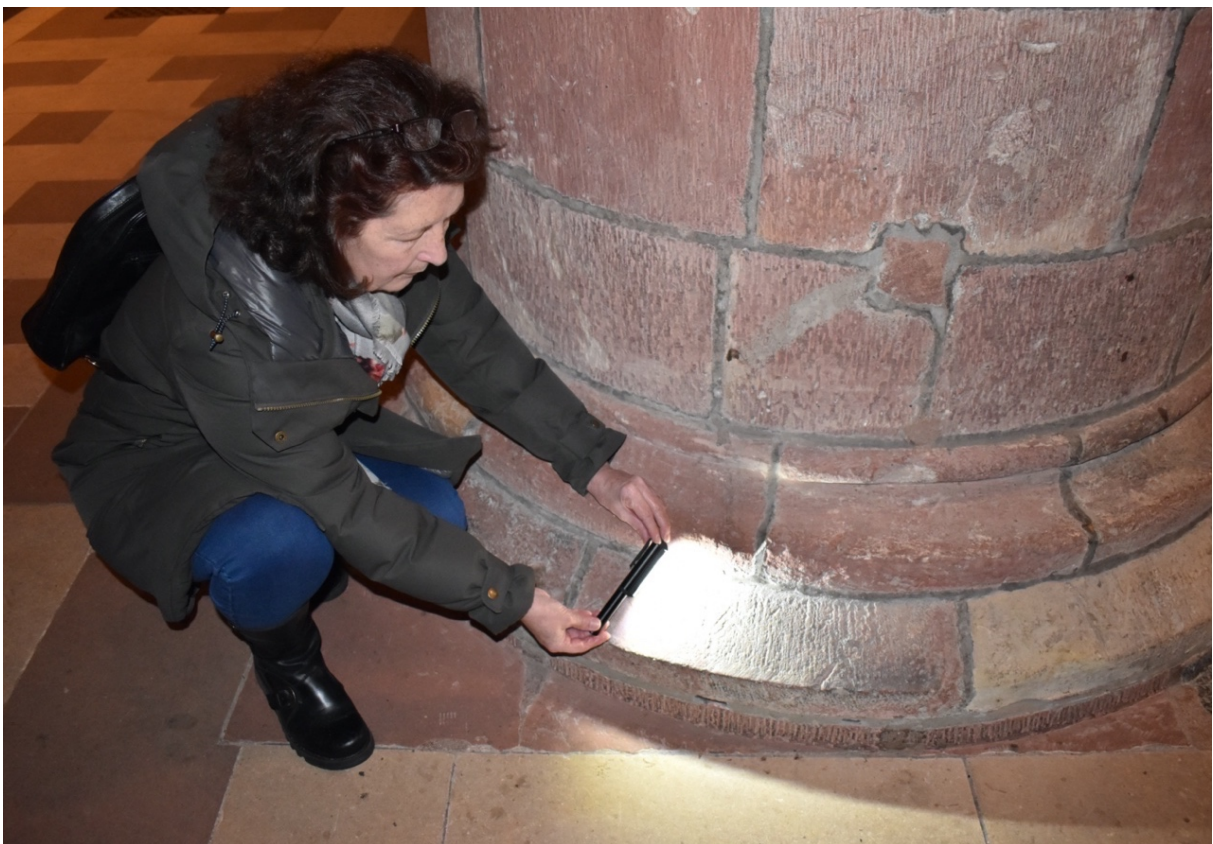
Figure 7: Recording masons' marks in the nave during the survey. Photograph © Antonia Thomas.

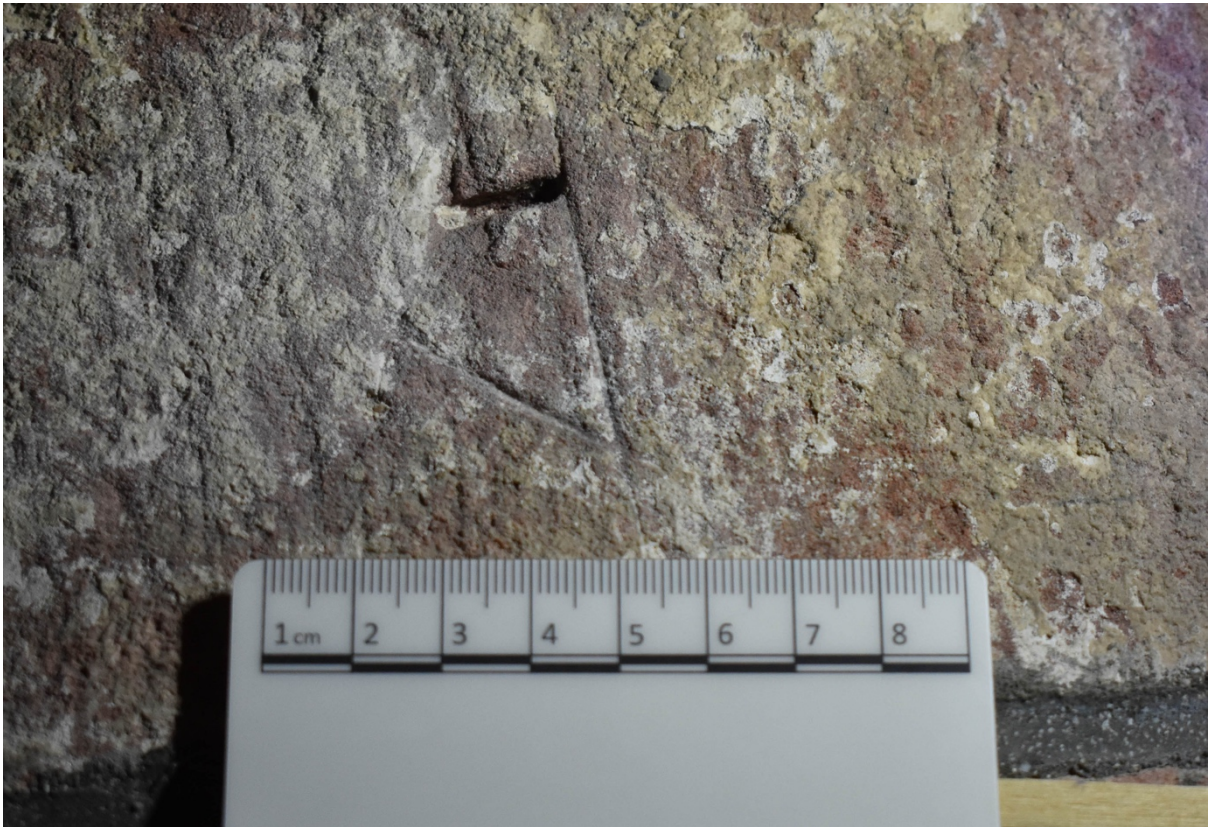
Figure 9: An example of a masons' or merchants' mark which had not been catalogued previously, recorded on Pillar 9 (P9_002). Photograph © Antonia Thomas.

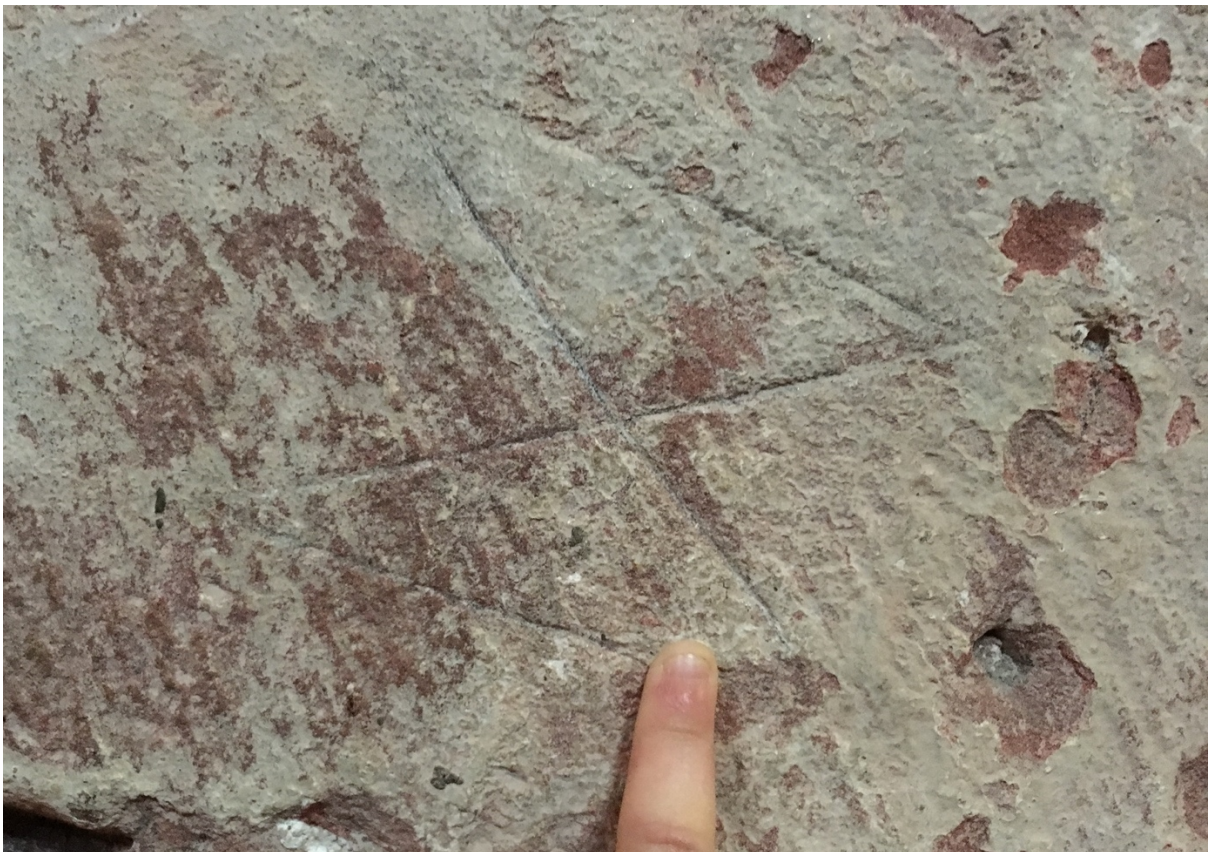
Figure 10: An example of a 'sandglass' masons' mark, recorded on Pillar 13 (P13_007). Photograph © Antonia Thomas.

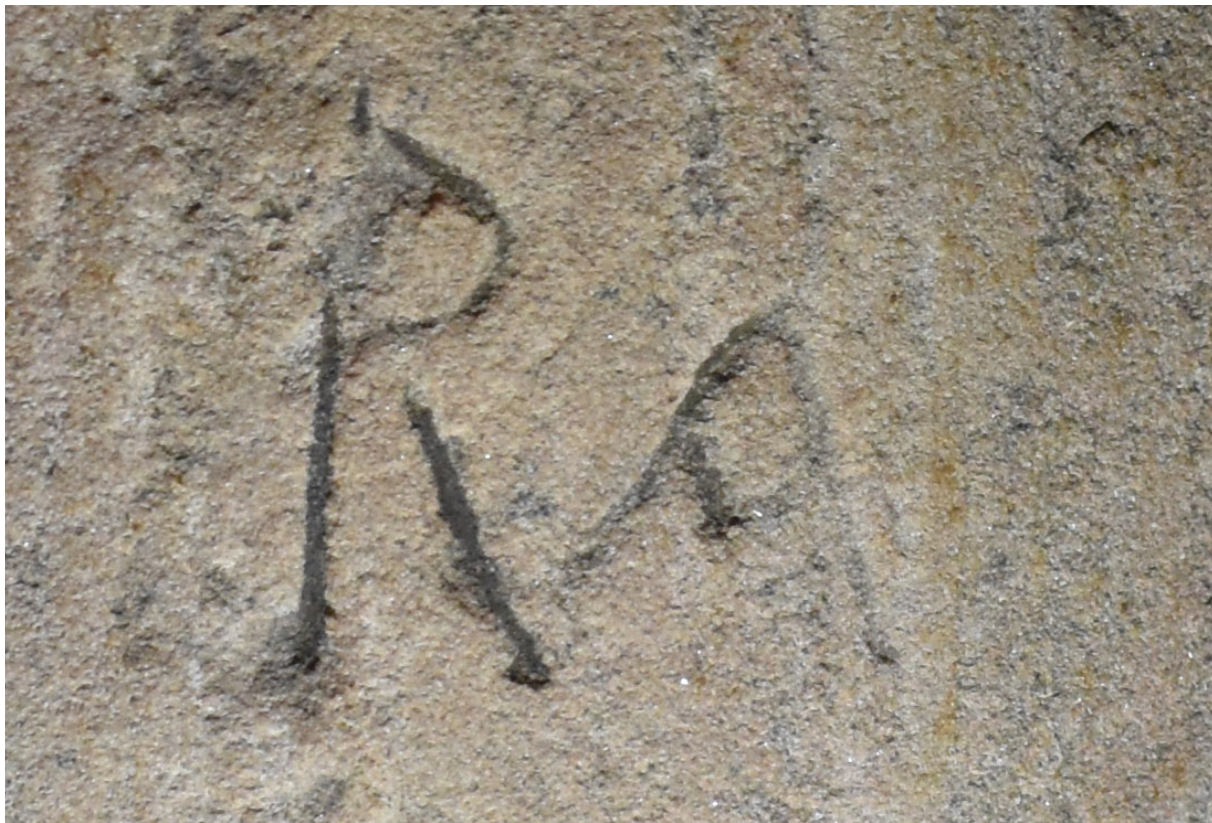
Figure 12: Carved initials 'RA' on the side of the Cuthbert Memorial in the western end of the nave on the north side (NN2_002). Photograph © Antonia Thomas.

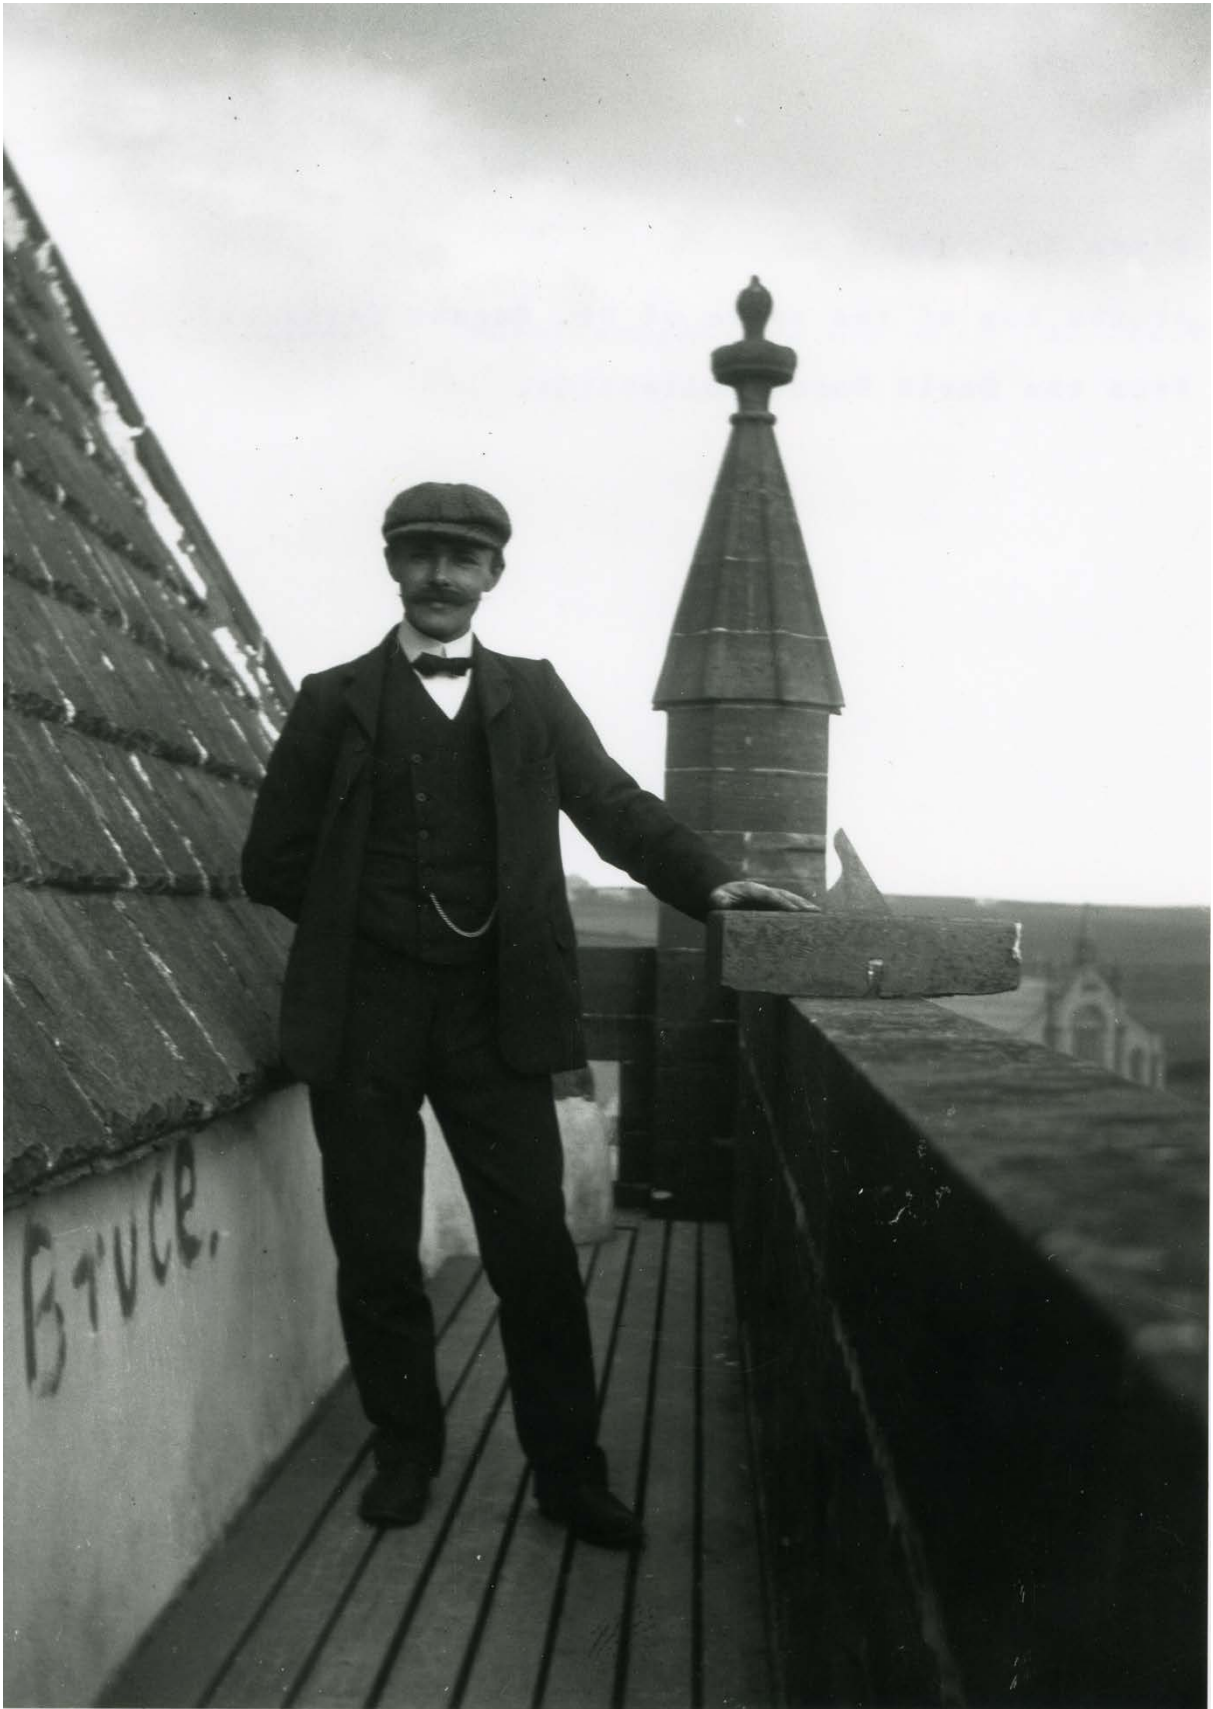
Figure 14: Photograph of David Horne, taken by an assistant, on the tower of St Magnus Cathedral, showing painted graffiti in the background. Image © Orkney Library and Archive, David Horne Collection.

Cursiter stated that, 'there were many letters cut and painted onto the walls of the Cathedral tower, and the cutting had gone on ever since he could remember. He had probably cut his own initials there about twenty-five years ago...There were a great many names within the tower, one of them being that of a distinguished person – Prince Alfred – and the size of the letters would be about two feet. There had never been any public warning against the practice' (Orkney Herald, Wednesday 29th July 1891). Thereafter, the Magistrates' Orders forbidding graffiti in the cathedral were posted in the building, some of which survive in the upper levels (see Figure 13). Following the court case, the cathedral also employed its first custodian, Peter Wick, who was employed specifically to prevent further damage to the cathedral through people carving their names on the stonework.

Unfortunately for the current study, the upper part of the tower was rebuilt in the early 20th century, replacing the parapet and spire built in 1848 (RCAHMS 1946, 121). Some photographs do survive of the tower prior to the rebuild, however, such as an example from the David Horne collection. The example shown in Figure 14 very clearly shows the name 'Bruce' painted in the background, and it is hoped that further research into archive photographs of the cathedral might show other examples.

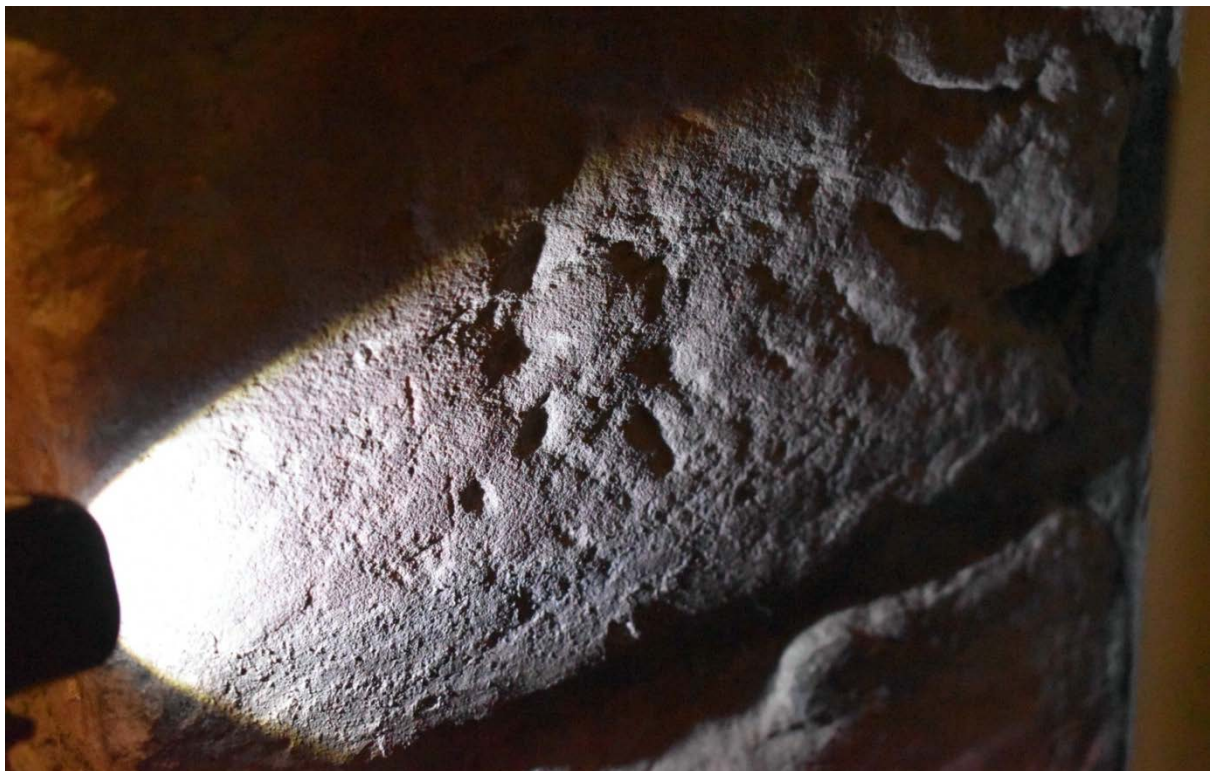
Figure 15: Example of dot pattern, recorded in the North Aisle of the Choir (NC2_002). Photograph © St Magnus Graffiti Project / OAS.

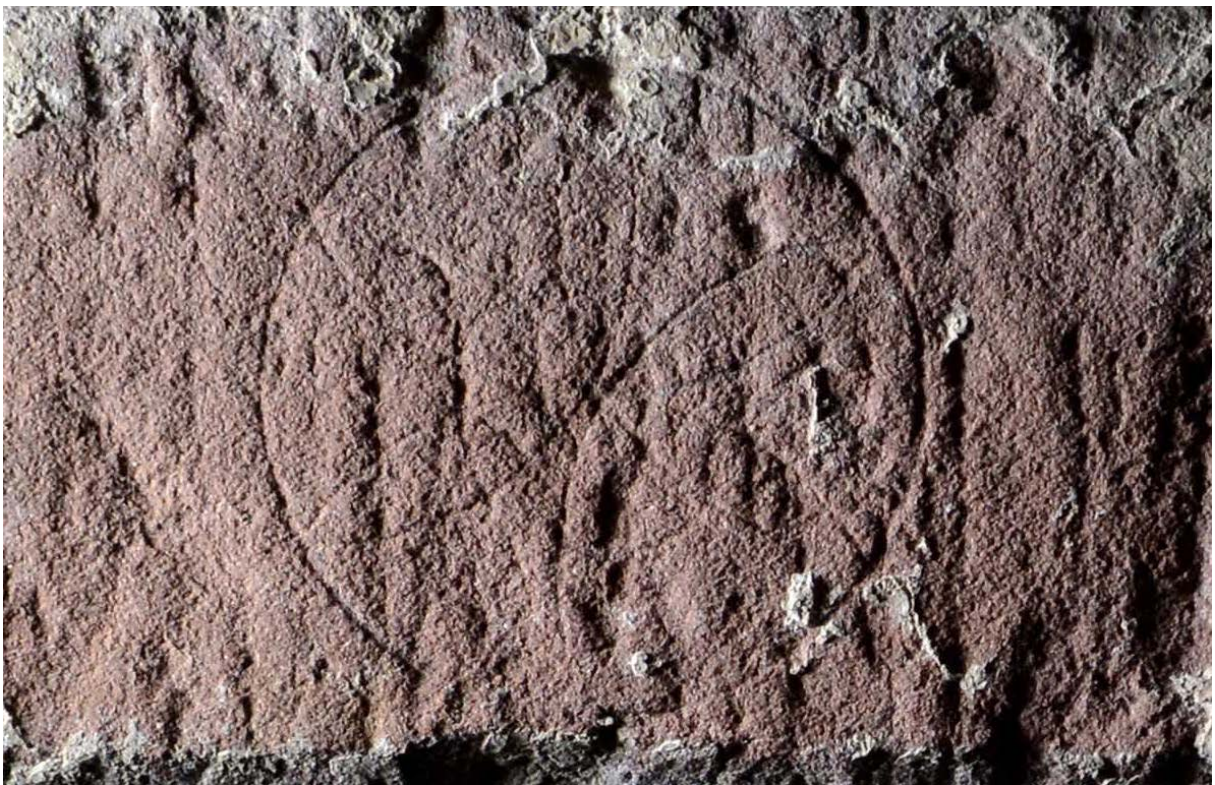
Figure 16: 'Daisywheel' or hexafoil in the string course of the wall of the South Nave. Photograph © Antonia Thomas.

Thomson was also the first person to record the 'daisywheel' or hexafoil on the string course between the Paplay Tomb and the tombstone of Nicola Traill in the wall of the south aisle of the nave (1954, 8-9; see Figure 16). Thomson also noted one or two stones with possible drawings on them, which he thought might be architectural sketches or plans of certain parts of the buildings, as found in other cathedrals. Intriguingly, Thomson did not give any further information about the location of these beyond being on pillars in the nave (1954, 9).

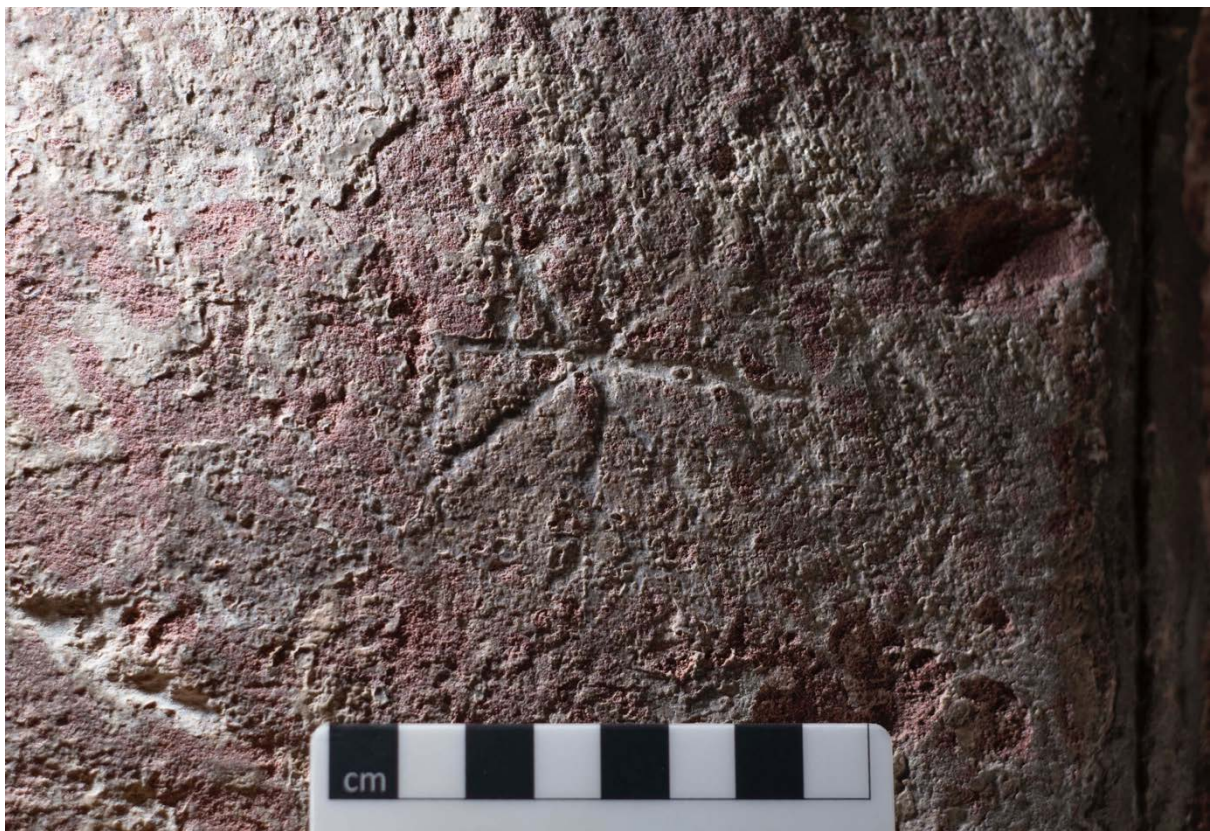
Figure 18: Asterisk on Pillar 21(P21_003). Photograph © Antonia Thomas.

These three examples are quite different from one another. P21_003 (Figure 18) is relatively crude but is similar to examples recorded in other medieval buildings in Scotland, such as Leuchars Church, Jedburgh Abbey and Dryburgh Abbey (Smith 1873, Plates XXI-XXII). At all of these sites these examples have been interpreted as masons' marks (Smith 1873; Wallace 2020), but these examples demonstrate the difficulty in interpreting such marks, many of which may have been made for different reasons, over a very wide timescale. P21_018, on the opposite side of the pillar, is much more lightly / sharply incised, and also seems to have other lines crossing the four lines forming the points, and a possible faint box or grid pattern visible around these lines (Figure 19 overleaf). This mark predates the repointing of the stonework, as it has been eroded when the earlier mortar was raked out, and the stone has suffered some decay to its surface around its edges. It is possible that this example is the remains of a merel pattern, a version of the Nine-Men's-Morris board and a frequent occurrence in medieval ecclesiastical contexts where is thought to have a ritual function (Berger 2004).

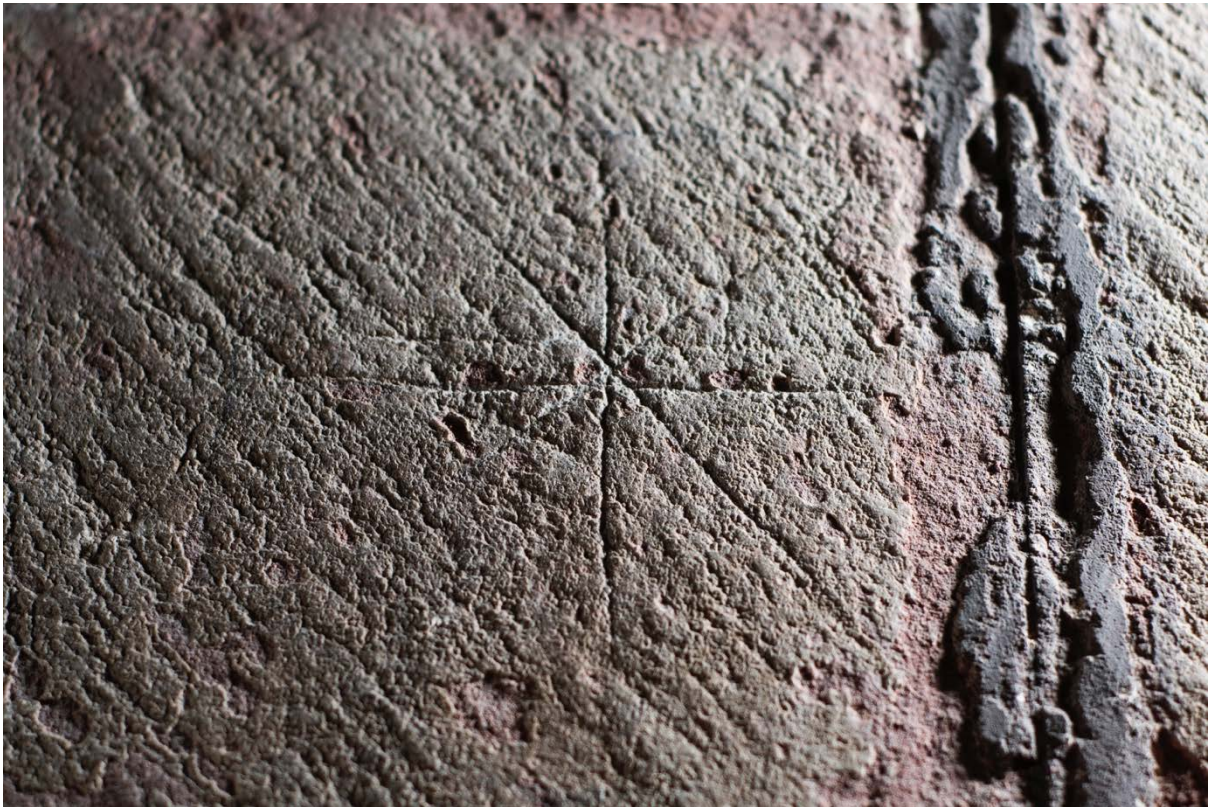
Figure 19: Asterisk, or possible merel pattern, on Pillar 21 (P21_018). Photograph © St Magnus Graffiti Project / OAS.

An indication of the level of decay in the stone surface is hinted at by the partial remains of P21_018, shown in Figure 19 above. The incised lines of this asterisk pattern were clearly once more extensive, and the lamination of the stone surface seems to have removed part of the pattern. The modern mortar, which appears to be much harder than the stone it is bonding, is likely one of the main culprits for this damage. In many parts of the cathedral, the soft stone

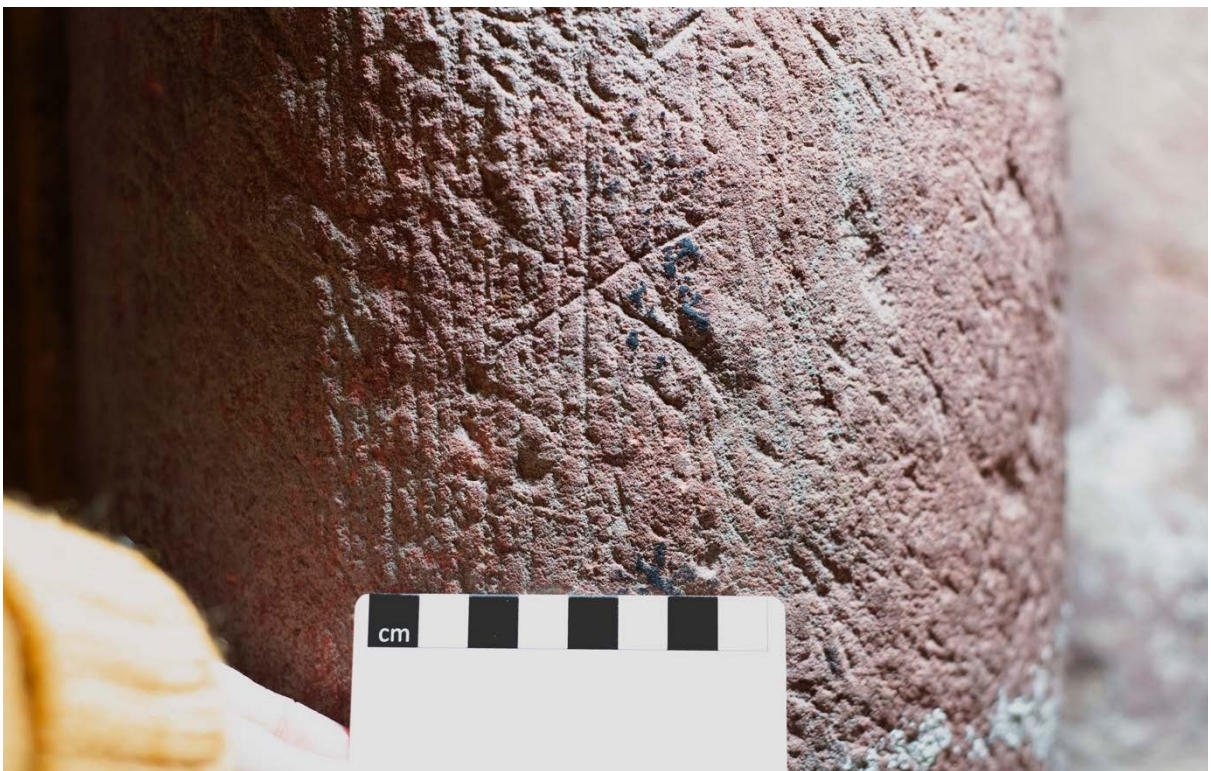
Figure 20: Six-pointed star carving, possibly a masons' mark, on Pillar 18 (P18_027). Photograph © St Magnus Graffiti Project / OAS.

Three 'asterisks' were also recorded during the survey. These include two eroded eight-pointed stars (P21_003 and P21_018) recorded on Pillar 21, which is located in the north aisle of the choir (see Figures 18 and 19 below), and a further six-pointed example on Pillar 18 (P18_027) in the crossing (see Figure 20).

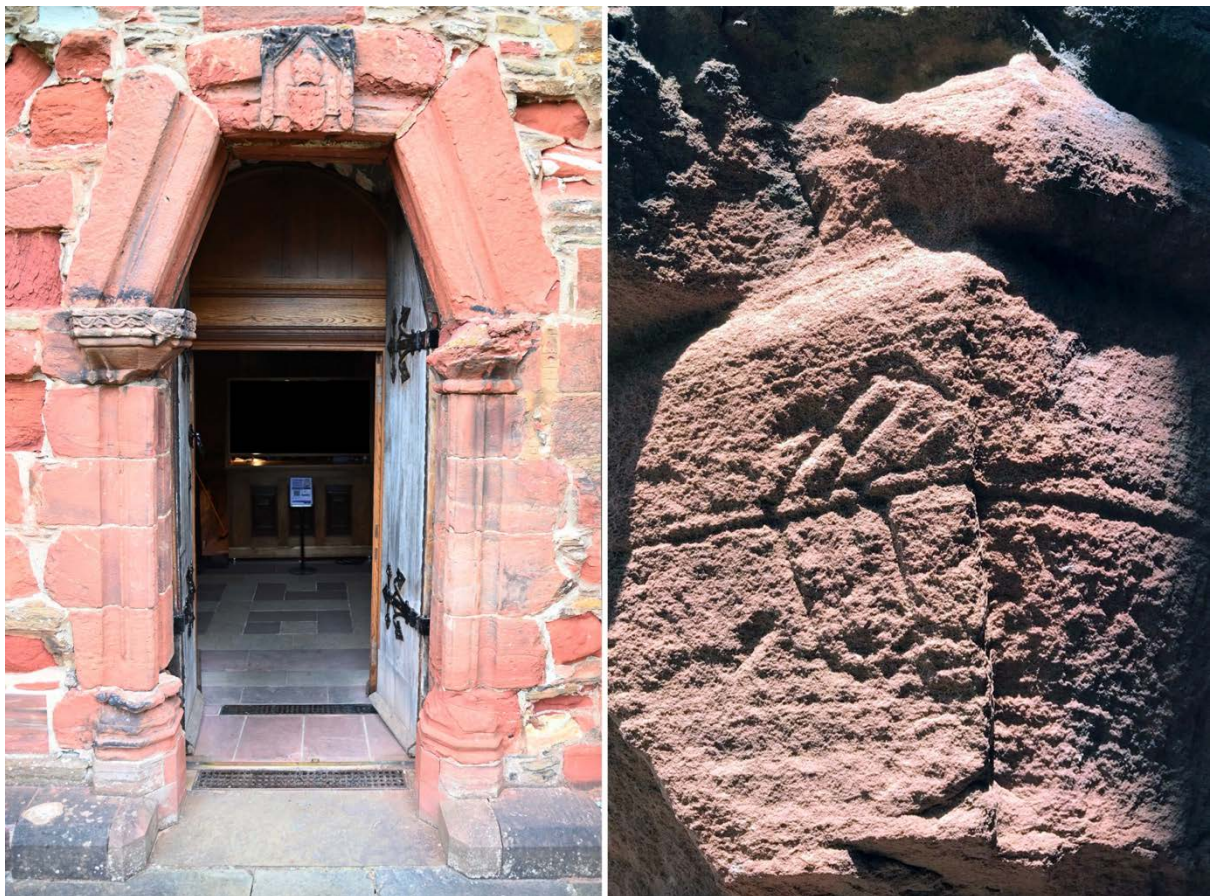
Figure 21: Previously unrecorded carving (right) on the capital of the left-hand jamb of the Bishop's Door (left) on the southern elevation of the cathedral. Photographs © Antonia Thomas / Fran Flett Hollinrake.

Other recorded marks highlight the role that light plays in the visibility of these carvings. In spring 2021, Fran Flett Hollinrake noticed a previously unrecorded carving on the left-hand side of the Bishop's Door in the southern elevation (Figure 21 below). This may be a masons' mark, as this doorway is a different constructional phase from most of the rest of the cathedral, as the doorway was a 16th-century insertion as part of the work carried out during the see of Bishop Robert Reid. This may explain why this mark is not found elsewhere, although it is also possible that this is a personal, family or heraldic mark relating to the Bishop himself. Examination in July 2021 showed a similar mark on the right-hand (easternmost) jamb capital. Further inspection of the external walls is recommended during raking sunlight conditions.

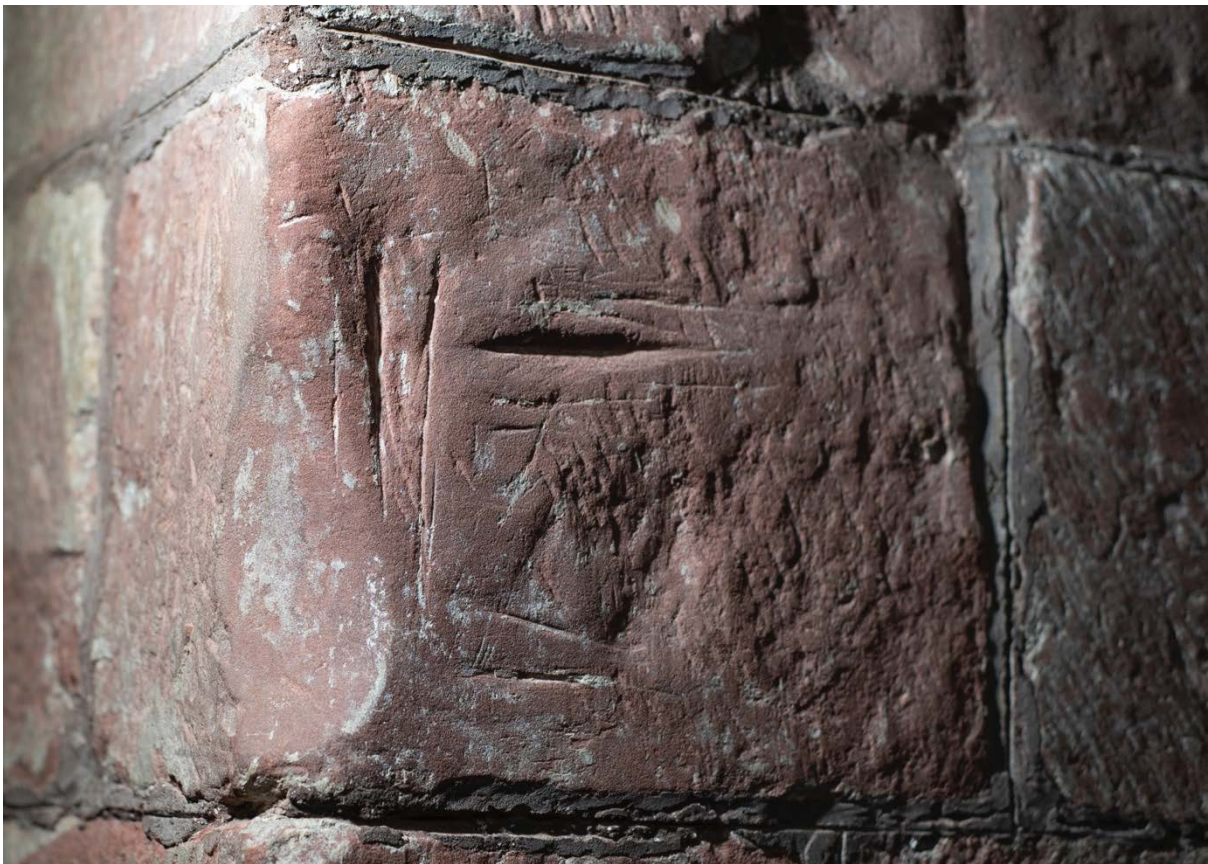
Figure 22: Carved grooves and smoothing visible on the corner of Pillar 21. Photograph © Antonia Thomas.

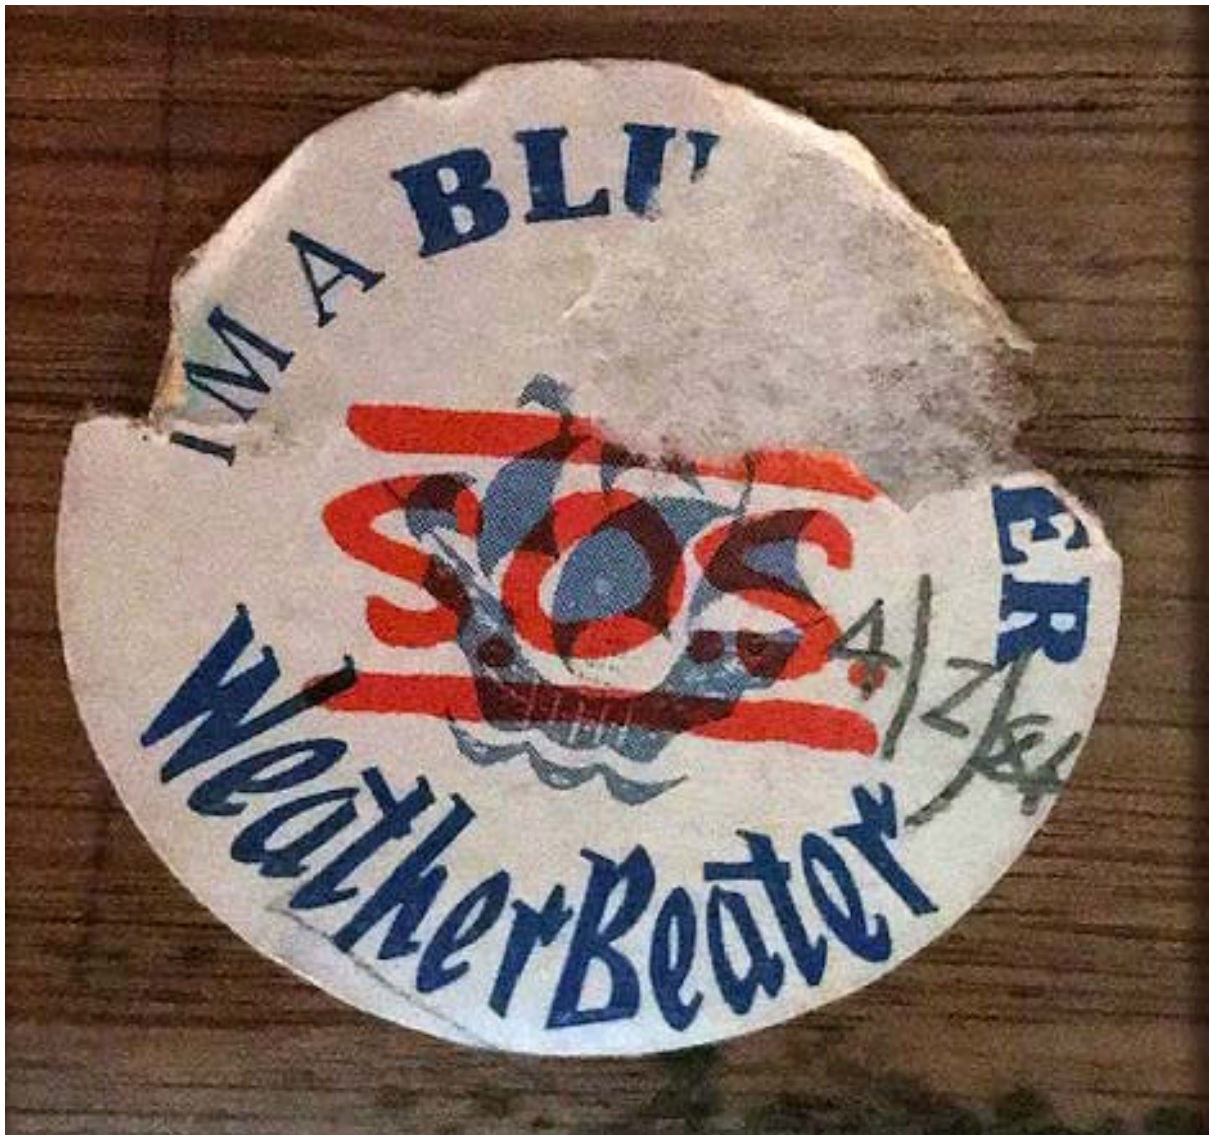
Figure 23: Blue Peter sticker recorded in the north choir stalls. Photograph © David McLoughlin / OAS.

Towards the end of the main phase of recording in 2020, several of the volunteers turned their attention to the furniture in the cathedral. This led to the discovery of a Blue Peter sticker in the north choir stalls (Figure 23), which is clearly dated 4/2/84, and is the most recent dated record from the project so far.

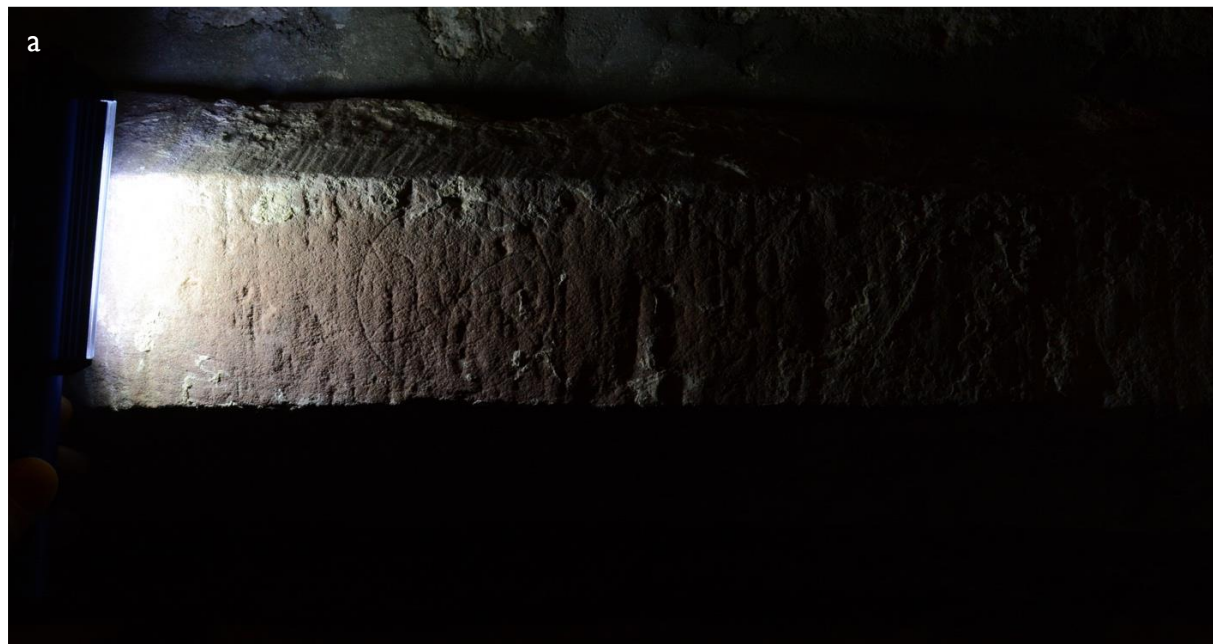
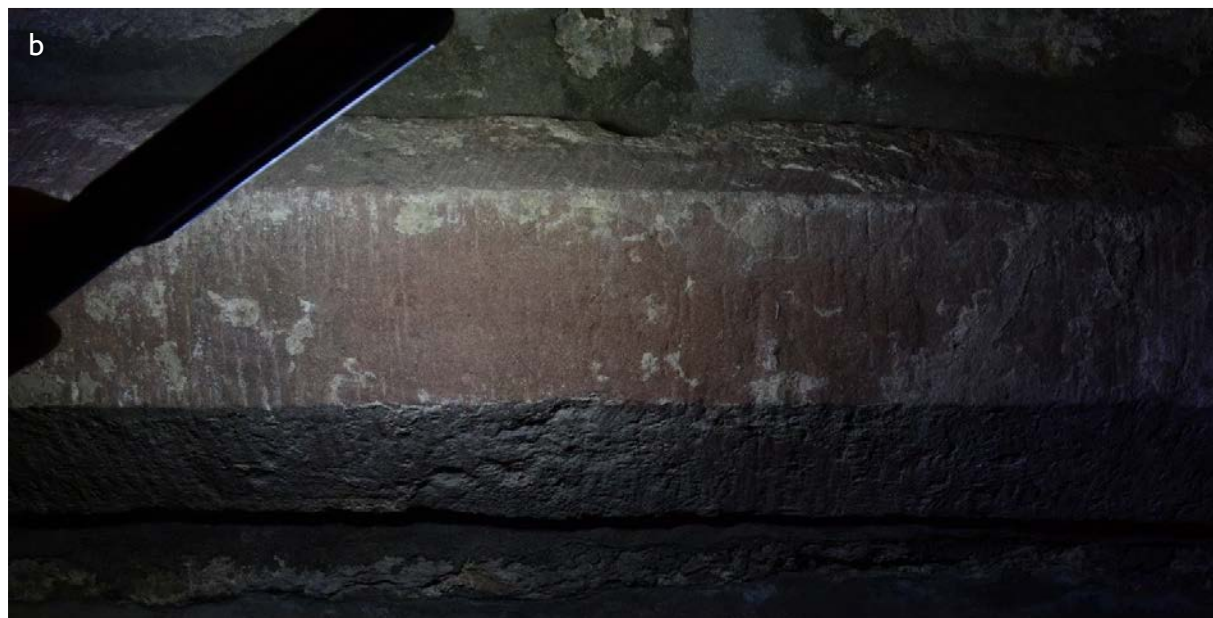
In the above left photograph (a), the LED light has been held far too close to the carving. The light has reflected off the stone's surface, causing glare and a strong contrast. In the above right photograph (b), the LED light has not been held at an oblique enough angle, causing a diffuse light across the stone. There is very little definition and contrast, making the finely incised lines of the carving almost invisible.
