St Magnus Graffiti Project, Stage 1

Survey Report

Survey Report (Final)

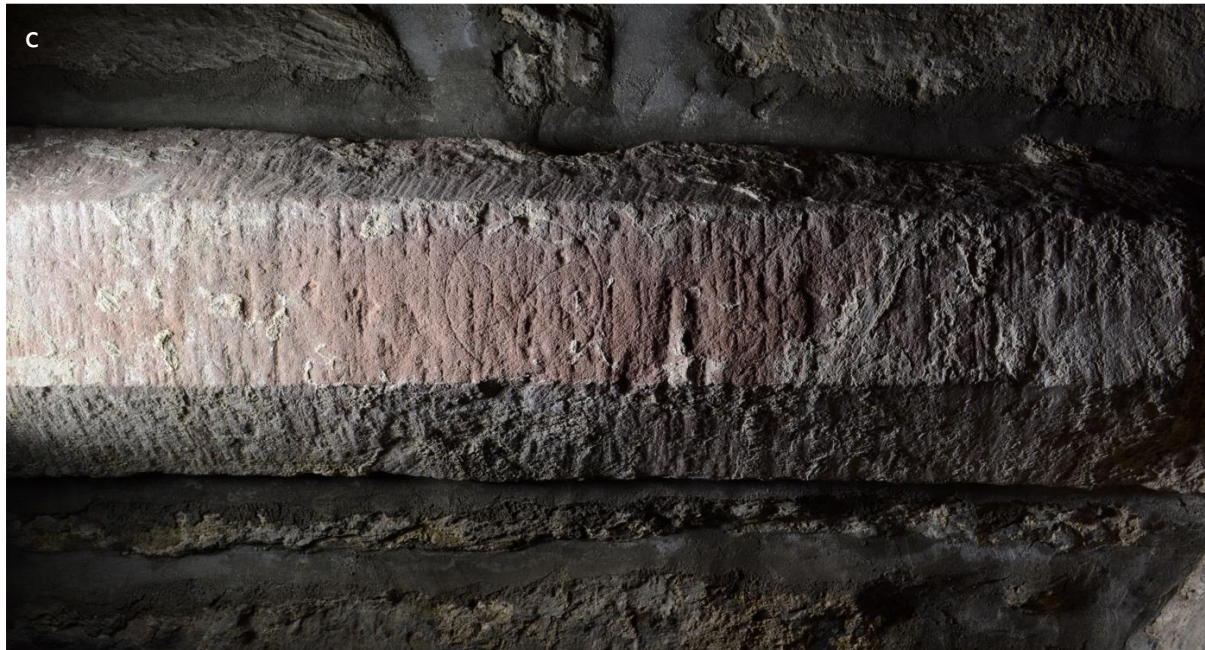
The above photo (c) has the light at just about the right distance to give the carving some definition. It shows the form of the stone well and contains enough of the surrounding stonework to be able to really see the context of the carving. However, you should *also* take a second shot which is more zoomed in, to be able to really focus on the carving itself.

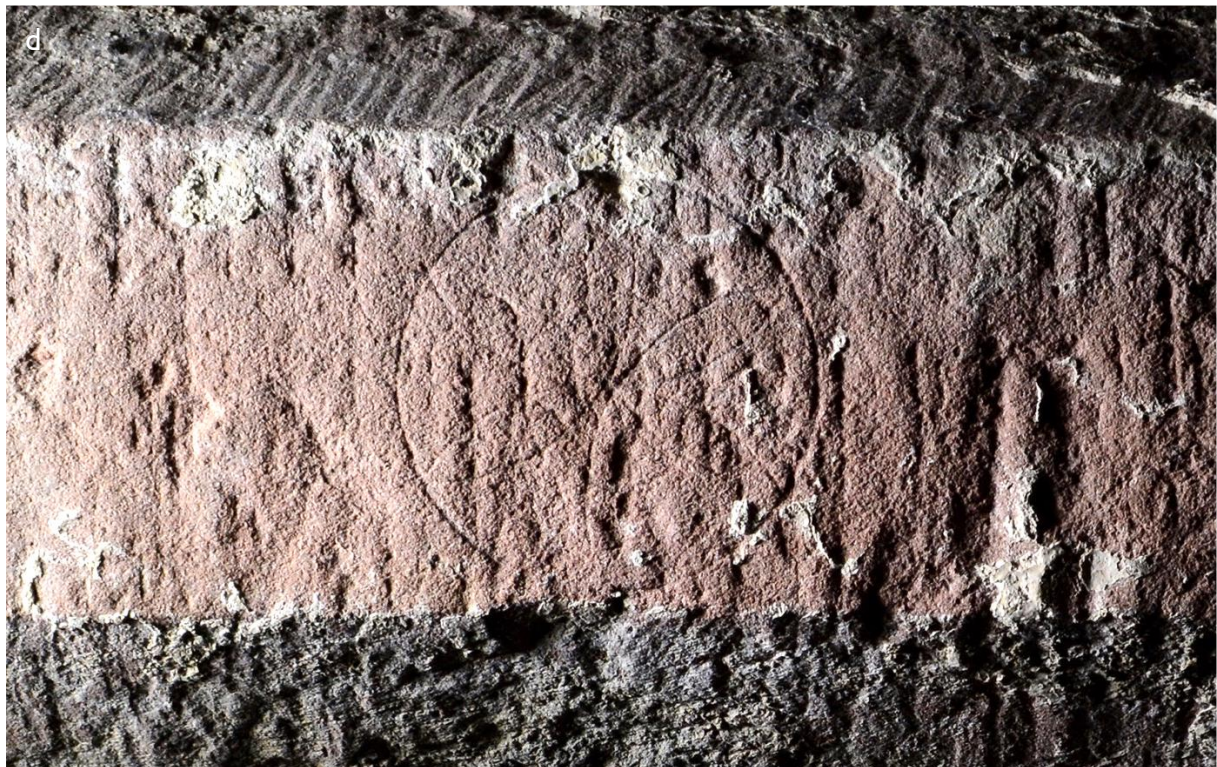
The above photo (d) shows the carving well. Where possible, please also take a photograph with a scale. With this in mind, an ideal photographic record for each individual graffiti / mark would comprise **at least 3** photos: a wider 'context' shot, and two detail shots, one with a scale and one without. Only ever hold the scale, never try to stick it to the wall.

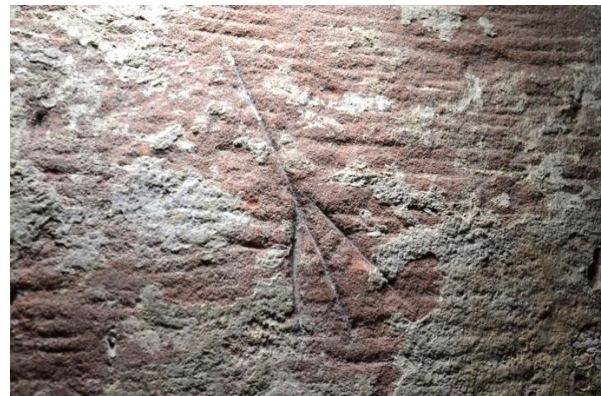
Masons' marks: The stonework in the cathedral, not surprisingly, has a host of different masons' marks from the last 870+ years. These were carved on the stones by masons themselves, during the construction, or restoration works. Mason's marks tend to be quite simple, usually neatly executed and involving straight lines (see pictures below).

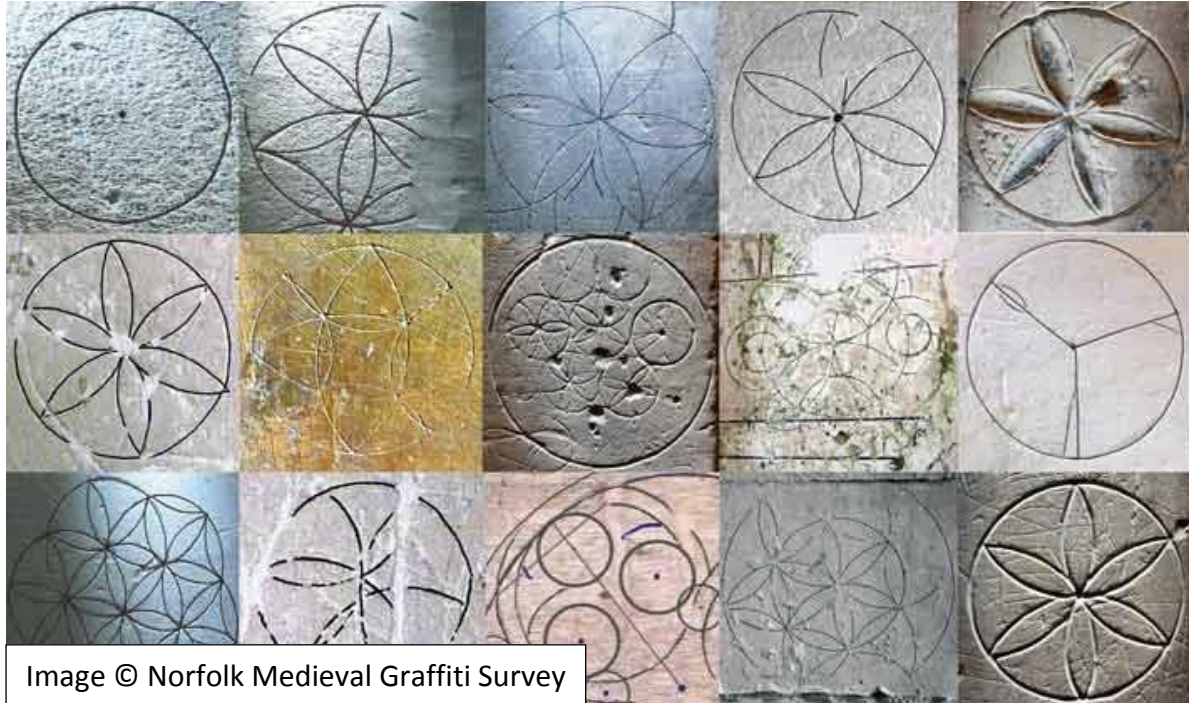
Compass drawn designs (hexafoils): such as the design shown in Section 4 above. These are extremely common in English medieval churches, as demonstrated by the large number recorded during the Norfolk Medieval Graffiti Survey (see below).
