Graffiti, carvings and inscriptions in St Magnus Cathedral

A self-guided tour

The St Magnus Cathedral Graffiti Project

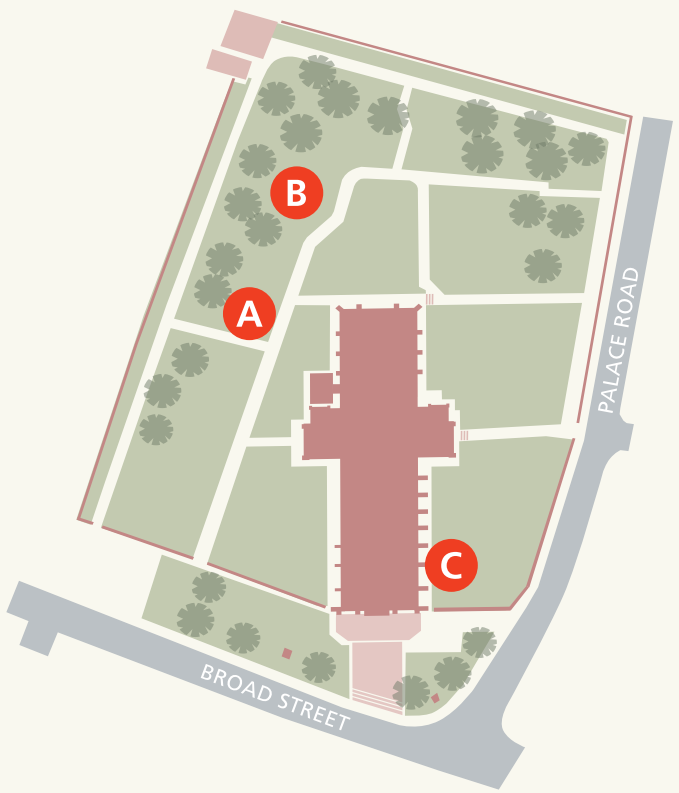
This is the gravestone of William Bisset (B), who was in charge of the restoration that was carried out in the cathedral in the 1840s. He died in 1848 and the stonemasons of the day carved their unique marks on this stone. They are very worn now but still visible.

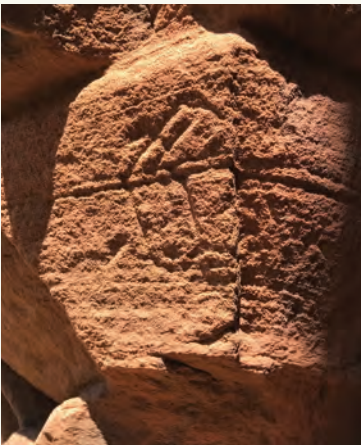
This carving can be found on the left hand side of the bishop's door (C). Could it show a mitre, the head-dress worn by bishops? This is a special ceremonial door, and the eroded coat of arms above it contains the shape of a mitre.

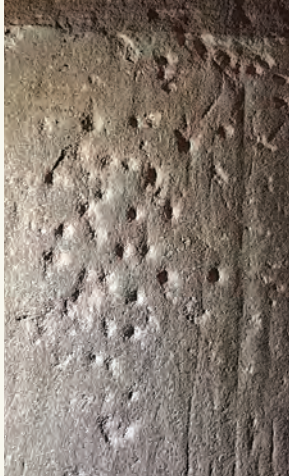
On the south-facing side of one of the pillars in the crossing (7) there is a clustered group of small pecked marks. These may have been made by pilgrims to mark their visit, something that is recorded at medieval pilgrimage sites elsewhere.

There are also several faint incised lines next to the pecked marks, but it is not clear what these were – perhaps the worn remains of a drawing?

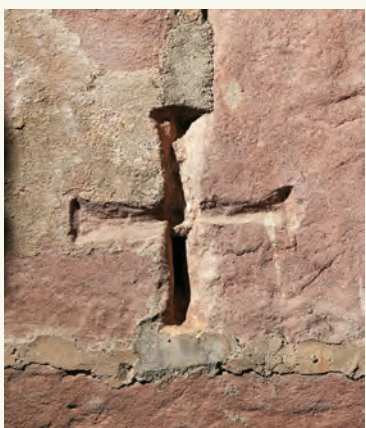
This is the deepest carved cross in the cathedral. This wall (8) was once plastered, so the carving must date to before that time, making it a very early example. It is in a prominent position, and would have taken a long time to carve out. It may have originally been a consecration cross, or a symbol of devotion.

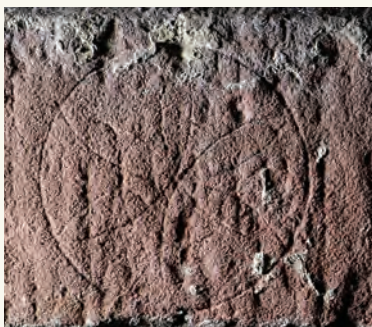
This hexafoil (meaning 'six-petalled flower') or daisywheel is scratched into the string course above and to the left of the Paplay tomb (9). These compass-drawn designs are found in many religious and non-religious buildings of all ages. They may have been simply decoration, but inside a church it is thought they could be apotropaic – marks of protection against evil.

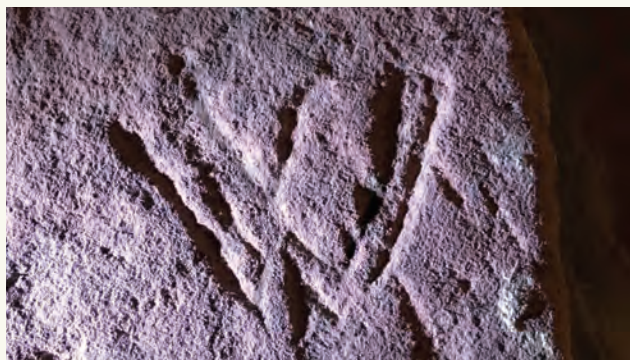
Many churches contain examples of these marks, which look like two V-shapes overlapping, or an inverted M-shape (10). One interpretation is that the two V-shapes could mean 'Virgo Virginum', Latin for 'Virgin of Virgins', and the 'M' would be for Mary. During the Middle Ages Mary was an extremely popular saint.
